WEST KILDONAN LIBRARY

BUILDING CONDITION ASSESSMENT, HERITAGE ASSESSMENT, CODE COMPLIANCE REVIEW, & FEASIBILITY STUDY

Winnipeg, Manitoba
March 2024

Prepared for:
The City of Winnipeg

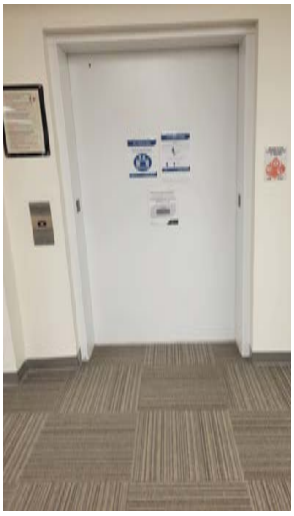
The existing elevator was installed in 1998 (it is 25 years old). The elevator was functioning at the time of the site walkthrough, however library staff have noted that there are ongoing issues that require maintenance.

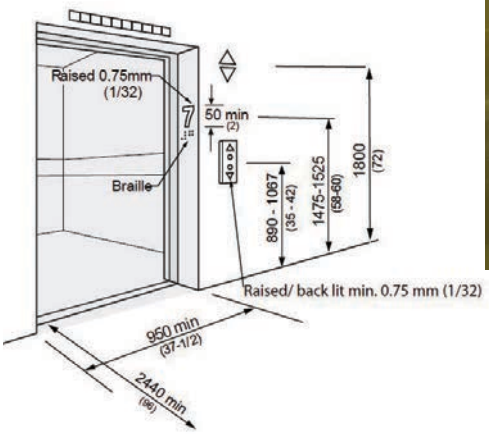
Elevator Hall Call Button

WADS indicates that "elevator doors shall incorporate pronounced colour contrast, to differentiate them from the surrounding environment. There shall be a pronounced colour contrast between the car sill and the facility floor". The existing elevator doors are approximately the same colour as the adjacent interior walls. This is not compliant with WADS. The car sill is contrasted from the adjacent carpet flooring, which is compliant with WADS.

Recommendations: Adding voice annunciation to the elevator would provide audible cues for individuals with vision impairments to identify different floor levels and the direction of travel. The elevator doors could be painted to provide more colour contrast - this would help those who are visually impaired to better identify the location of the elevator. To make the elevator dimensions compliant to the current WADS requirements, this would likely involve the demolition of the exterior concrete block wall to increase the dimensions of the shaft, complete with new elevator installation. Given the smaller size of the existing elevator, an angled mirror could be added to assist persons in wheelchairs to back out.

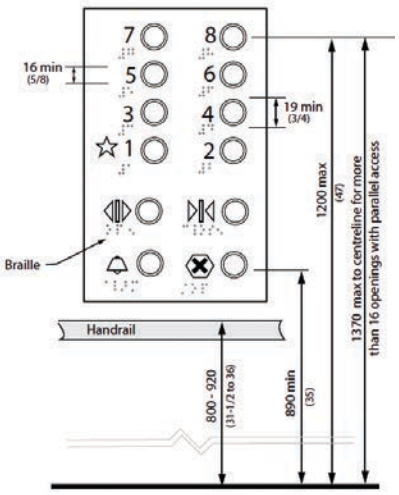
Elevator Floor Register Buttons

The floor register buttons exceed the WADS minimum of 19 mm (3/4 in.). All car control buttons are designated by Braille characters and by raised standard alphabet characters exceeding the minimum 1/2" height - this is compliant with WADS.

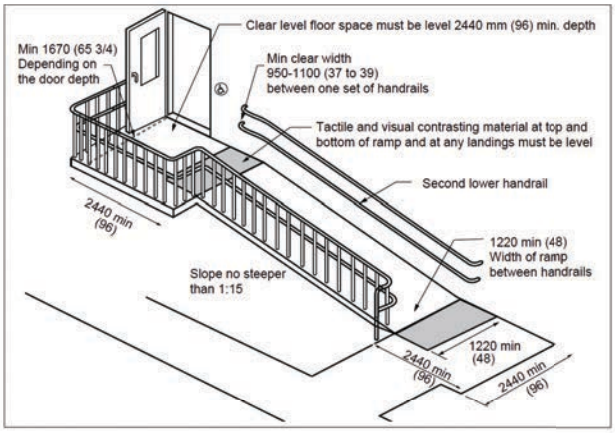
WADS indicates that landings shall "have a minimum size not less than 2440 x 2440 mm (96x96 in) if located at the top or bottom of a ramp". The bottom landing where the existing ramp meets the sidewalk is not large enough. This condition is not compliant with WADS.

Exterior Ramp
View to Sidewalk

Recommendations: Refer to the recommendations suggested for Ramps, Handrails and Guards in the Exits section in Part 7. Handrails/guardrails should be replaced with WADS compliant guardrails and handrails (on both sides). Detectable warning surfaces should be added. A new (larger) bottom landing and an intermediate landing could be added.

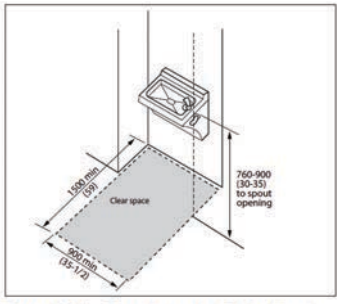
Risk to occupant safety: **Low.** This condition presents little risk to occupants, but reduces the accessibility of the space. There is a minor risk of someone who is visually impaired bumping into the drinking fountain, since there is no warning surface below it.

Existing Drinking Fountain

Recommendations: The drinking fountain could be replaced with an accessible model. A warning surface could be added below the fountain, or the fountain could be relocated so it does not project into the accessible route.

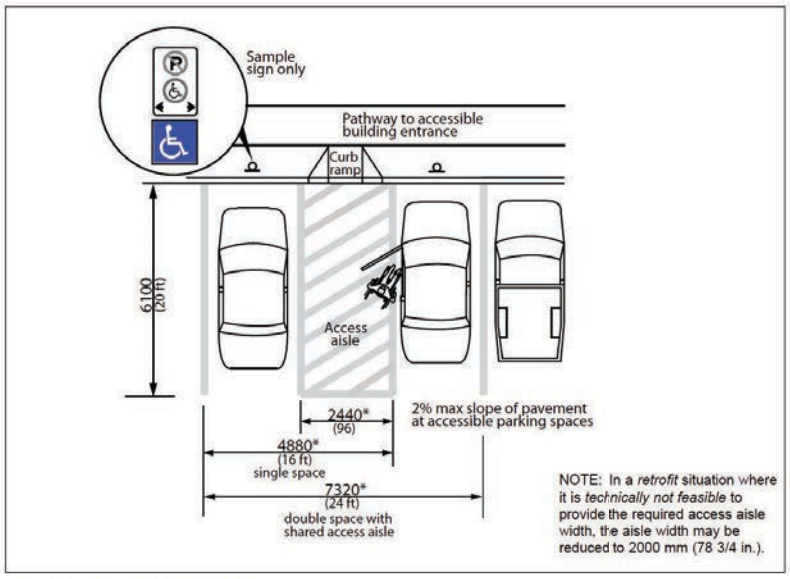
Risk to occupant safety: **Low.** This condition presents little risk to occupants, but reduces the accessibility of the site.

Accessible Parking Stall

Recommendations: Signage could be added to the parking space. A larger aisle would be difficult to accommodate in the existing accessible stall. Some of the existing non-accessible stalls could be replaced with a properly-sized, accessible stall and aisle by re-painting the lines. The parking lot paving could be regraded to comply with WADS.

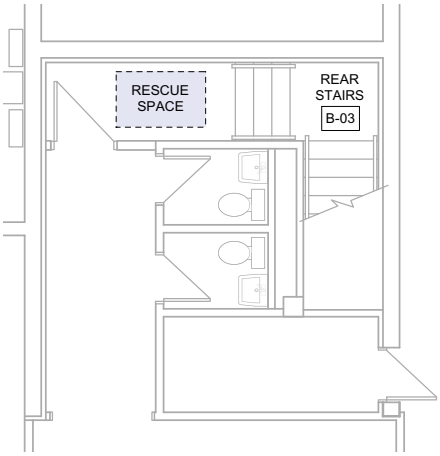
Risk to occupant safety: **High.** This condition presents high risk to occupants. In an emergency situation, if the elevator becomes inoperable, there is no protected area for those in wheelchairs or with mobility devices to wait for assistance during a fire.

Rescue Spaces that Could be Provided in Front Stair - Basement Level

Rescue Spaces that Could be Provided in Rear Stairs - Basement Level

Recommendations: Refer to the recommendations provided in Part 7 for Exits and Safety Within Floor Areas.

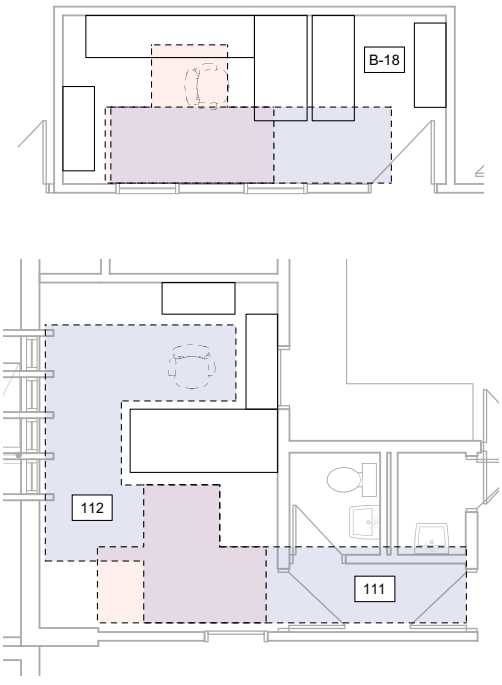
Analysis of Offices (for Accessible Clearances)

Analysis: WADS states that "if it is technically infeasible to have all offices accessible, at least 25% of the total offices within a floor area shall meet the requirements of this section". WADS requires that offices shall "incorporate a clear space allowing a person in a wheelchair to make a 180 degree turn (See figure 1.1.1.5); and incorporate an accessible route through the space that does not require the person in a wheelchair to travel backwards to enter/leave the space".There are 3 office spaces in the library: Room 108, Room 112, and B-18. To be compliant with WADS, at least one of the offices on the main floor and in the basement must be accessible. On the main floor, Office 112 has the accessible clearances, but Hallway 111 (leading to this office) does not qualify as an accessible route. Office 108 has adequate clearances for accessibility. The only basement office, Room B-18, does not have the required clearances to be accessible, so the building is not compliant with WADS.

Risk to occupant safety: **Low.** This condition presents little risk to occupants, but reduces the accessibility of the space. Those in a wheelchair cannot properly access the basement offices.

Recommendations: An alternate, accessible office could be provided elsewhere in the basement.

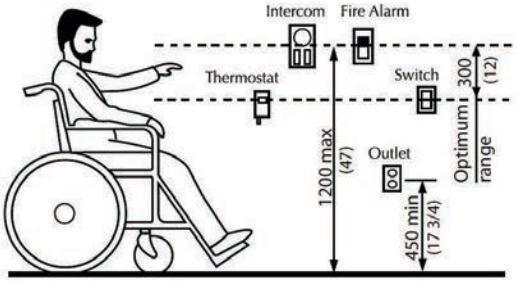
Risk to occupant safety: **Low & Medium.** Light switches and thermostats present low risk to occupants if they can't be accessed by someone in a wheelchair, but reduces the accessibility of the space. If the fire alarm pull station can't be accessed by someone in a wheelchair, there is a risk that a fire will not be quickly detected by other occupants in the building.

Light Switch Height (Too Tall)

Recommendations: These controls should be relocated where possible to comply with WADS.

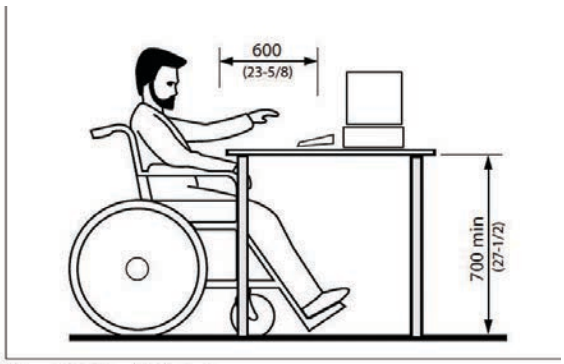
Figure 3.6.3.3 Work Surfaces

Main Floor - Work Surfaces

Recommendations: Accessible workstations could be added or could replace existing workstations. Height adjustable tables could be added. The existing library stacks could be replaced (if they are not heritage protected items). The location of stacks should be adjusted if the 1100mm aisle requirement is not met. The height of the book slots could be adjusted. The book slot could be relocated (or the washroom size adjusted) to provide the clear platform required in the north entrance. Headphones should be provided for public use at the audio rentals, or a separate, acoustically separated space could be provided for listening.

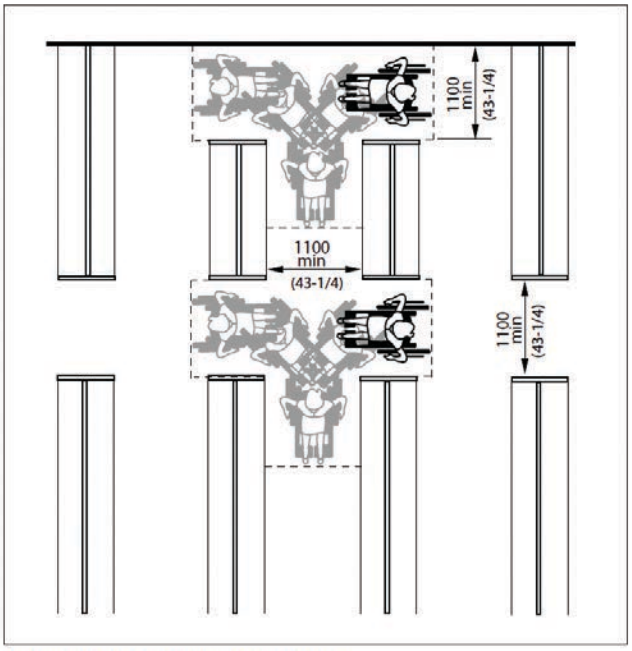
Figure 3.6.3.1 Library Stack Aisle Width

WADS states that "where shelving is provided at fixed seating, tables or study tables, the shelving shall be no higher than 1370 mm (54 in) from the floor to the bottom of the highest shelf". The existing library shelving/stacks are too high (and too low) on the main floor and in some locations on the basement level. This is not compliant with WADS. The typical clear aisle space between the stacks in the library appears to exceed the 1100mm minimum, and is compliant with WADS.

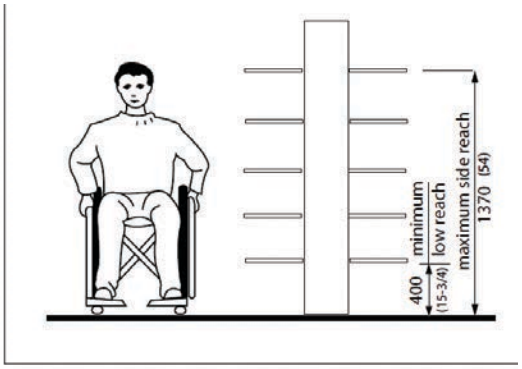
Figure 3.6.3.2 Library Stack Reach Heights

Main Floor
Typical Library Stacks
